Bulletin No. 324 Series E, Seismological Methods 6

Statistics and general information 60
THE EFFECTS OF THE EARTHQUAKE AND FIRE ON BUILDINGS, ENGINEERING STRUCTURES, AND STRUCTURAL MATERIALS, BY JOHN S. SEWELL 62
Introduction 62
Scope of the investigation 62
Acknowledgements 63
Extracts from the report of a committee of the National Board of Fire Underwriters on San Francisco conditions 64
Some features of the earthquake and fire 66
Amount of destruction due to the earthquake and fire, respectively 66
Fire-fighting operations; the use of dynamite 66
Temperatures of the Baltimore and San Francisco fires 68
Earthquake- and fire-resisting qualities of structures and structural materials 69
Effect of fire on Government and class A commercial buildings 69
Vaults and safes 69
Behavior of structural members and materials 71
Behavior of individual structures 76
Academy of Sciences building 76
Ætna (Young, or Commissary) Building 76
Appraisers' warehouse 77
Aronson Building 78

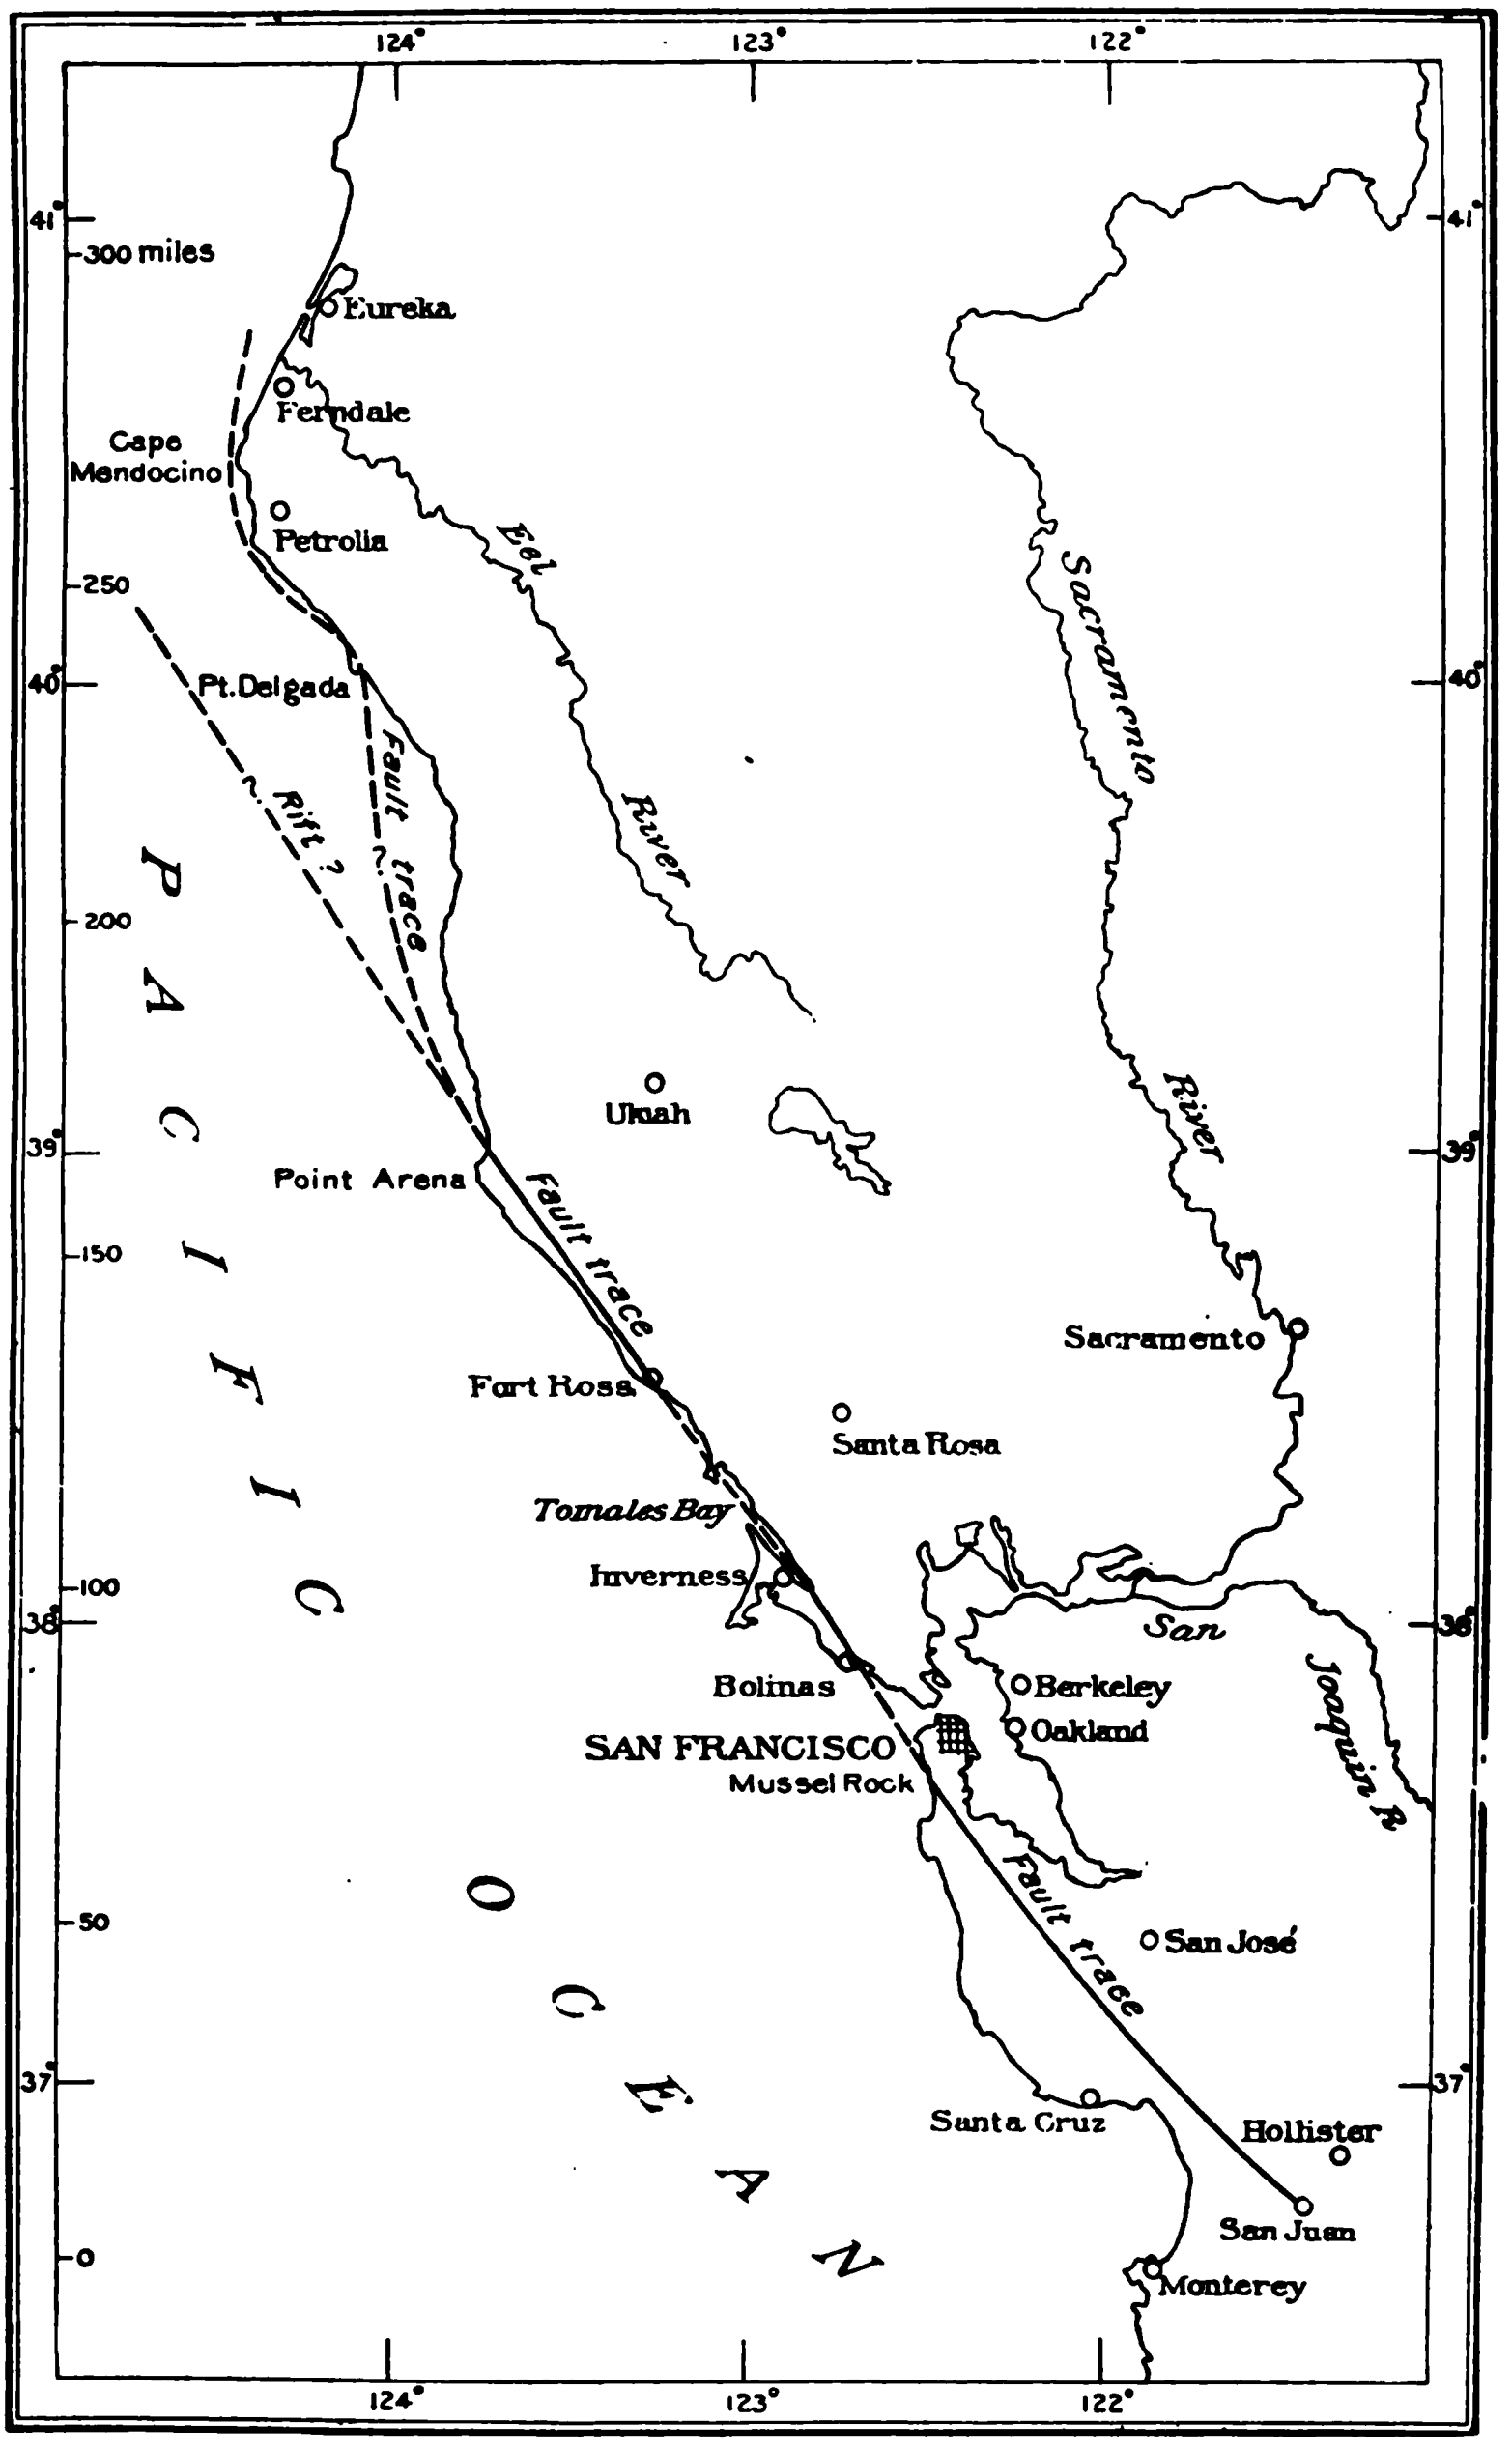
FIG. 1.—Map of the fault trace. Broken lines indicate alternative hypotheses as to its extension north of Point Arena.

The region of high intensity, to which most of the destruction was limited, is a belt 20 to 40 miles wide, extending from the mouth of Eel River at the northwest to Priest Valley at the southeast (fig. 1). This belt includes the surface expression of the principal fault—a feature distinctively known as the fault trace—a large number of cracks, and many local and superficial dislocations of soil and rock variously characterized as landslides and slumps.

Between Point Arena and Fort Ross the course of the fault trace (see fig. 1, p. 3) is approximately parallel to the coast, passing to the east of all the coastal towns. From Fort Ross to the head of Tomales Bay it traverses the water, except at Bodega Bay and Preston Point, where for short distances it crosses the land. It again enters the water at Bolinas Lagoon, passing several miles outside the Golden Gate, and returning to the land at Mussel Rock, whence it follows a nearly direct course to San Juan. It does not touch any large town, but passes within a mile of Manchester, Plantation post-office, Fort Ross, Bodega, Inverness, Point Reyes station, Olema, Woodville, Bolinas, Woodside, Portola, Wrights, Chittenden, and San Juan.

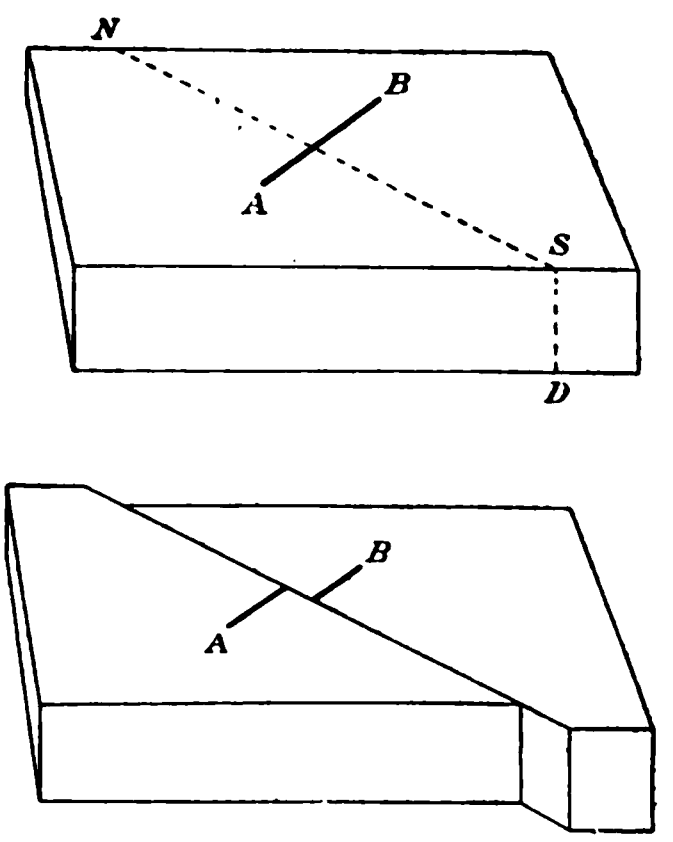
FIG. 2.—Diagrams illustrating the nature of the earthquake-making fault.

As the statement of these relations is sometimes found confusing, they are here illustrated diagrammatically. The upper diagram in fig. 2 represents a rectangular block as if cut from the land, the thickness being 25 feet, the length east and west (right to left) 150 feet, and the width 100 feet. The dotted line NS indicates the surface outcrop of the old fault plane, trending northwest and southeast, this plane cutting the face of the block in the vertical line SD. AB stands for any straight line on the surface of the land—such as would be defined by a road, a fence, or a row of trees—crossing the fault outcrop at right angles. The lower diagram represents the same

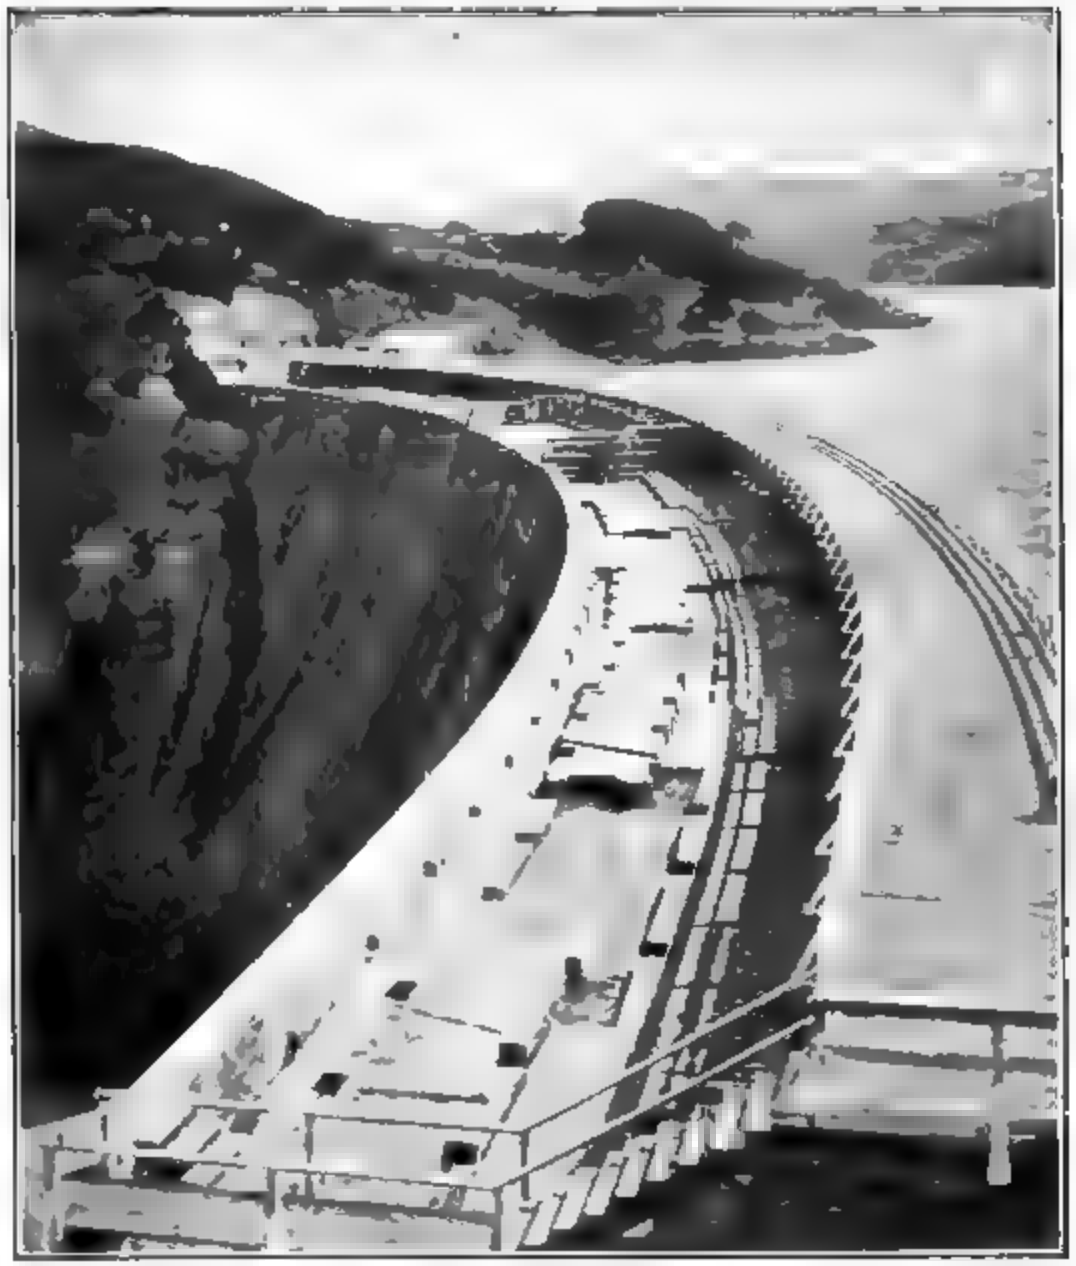
A RACKING AND SPALLING OF CONCRETE PIER DUE TO EARTHQUAKE

Near south abutment of Southern Pacific Railroad bridge over Pajaro River Photograph by Richard L. Humphrey

B. ENDURANCE OF CONCRETE DAM NEAR FAULT TRACE, AT CRYSTAL SPRINGS LAKE, SAN MATEO.

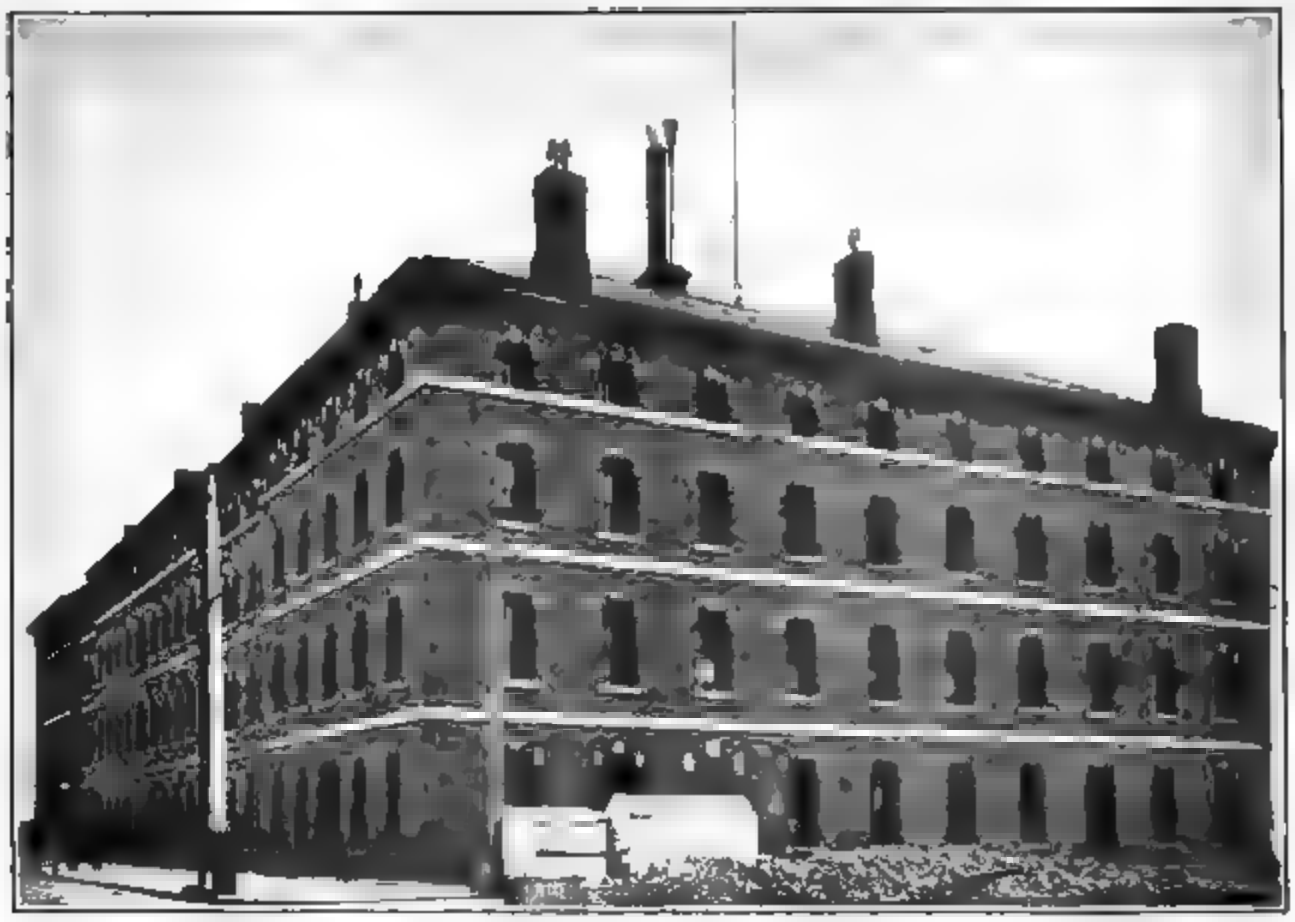
B FAILURE OF TERRA-COTTA COLUMN COVERINGS, RESULTING IN BUCKLED COLUMNS, ENDURANCE OF CINDER-CONCRETE FLOORS; CENTER OF GROUND FLOOR, ARONSON BUILDING, SAN FRANCISCO

A EARTHQUAKE ENDURANCE OF A WELL CONSTRUCTED BRICK BUILDING. APPRAISERS' WAREHOUSE, SAN FRANCISCO

The walls were built with full-header courses and show only a few slight cracks, although the building was located on alluvial soil. Photograph by Richard L. Humphrey

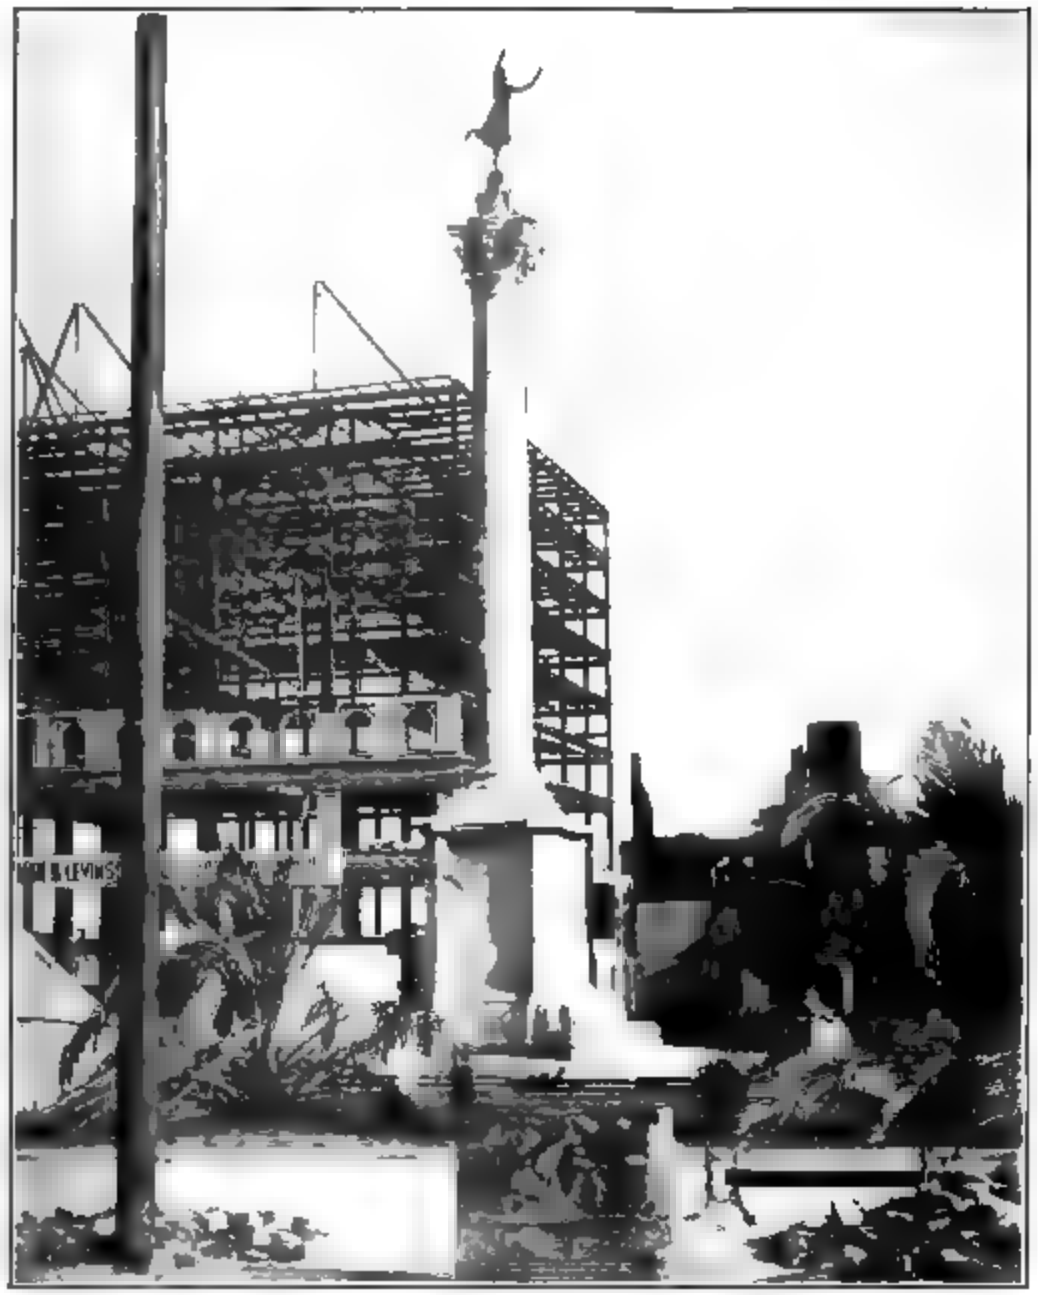
B. COLLAPSE OF FLOOR PANEL, CAUSED BY LOAD FALLING FROM A FLOOR ABOVE, THIRD FLOOR OF ÆTNA BUILDING, SAN FRANCISCO.

The failure of the upper floor was due to the softening by heat of reenforcing steel bands. Photographs by Richard L. Humphrey

A EARTHQUAKE DAMAGE MINIMIZED BY SPECIAL CONSTRUCTION DEWEY MONUMENT, SAN FRANCISCO

The drums on the shaft were displaced slightly, but were kept from falling by a steel core. Photograph by John Stephen Sewell.

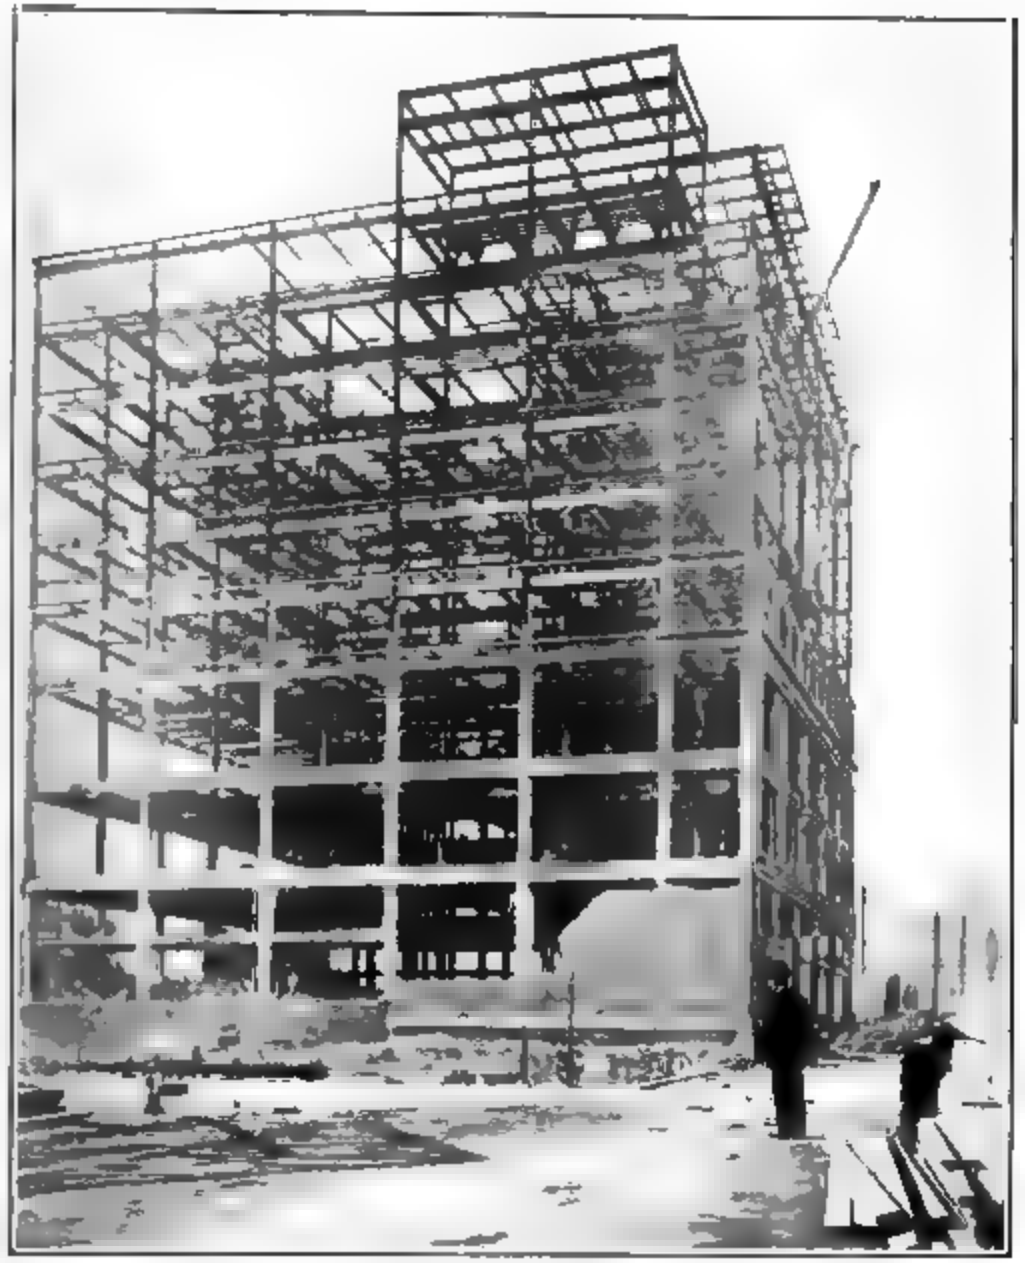
A BEHAVIOR OF STEEL FRAME, BUTLER BUILDING (INCOMPLETE), AT THE SOUTHWEST CORNER OF GEARY AND STOCKTON STREETS, SAN FRANCISCO

Walls taken down in places because of earthquake damage, although damage to steel

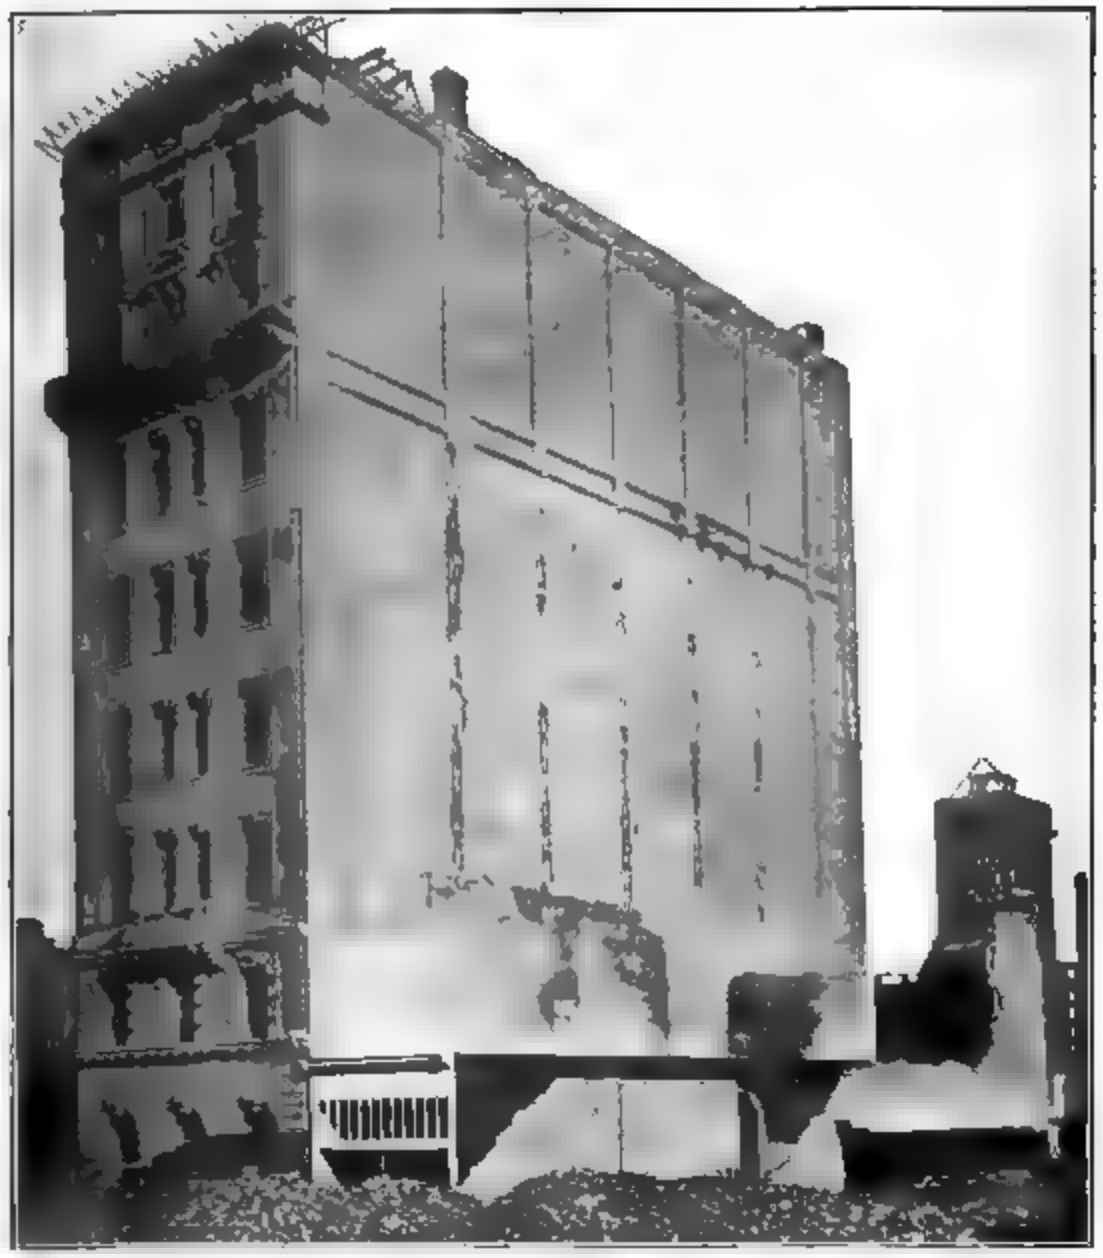
B. BUCKLING OF BASEMENT COLUMN DUE TO FAILURE OF TERRA-COTTA COVERING IN FIRE, MILLS BUILDING, SAN FRANCISCO.

A. ENDURANCE OF A WELL-PROTECTED BUILDING SUBJECTED TO SEVERE HEAT, MAIN EXCHANGE OF PACIFIC STATES TELEPHONE AND TELEGRAPH COMPANY, SAN FRANCISCO

Rolling shutters, self-supporting brick walls, concrete floors, and concrete protection for columns and girders. Photograph by Richard L. Humphrey.

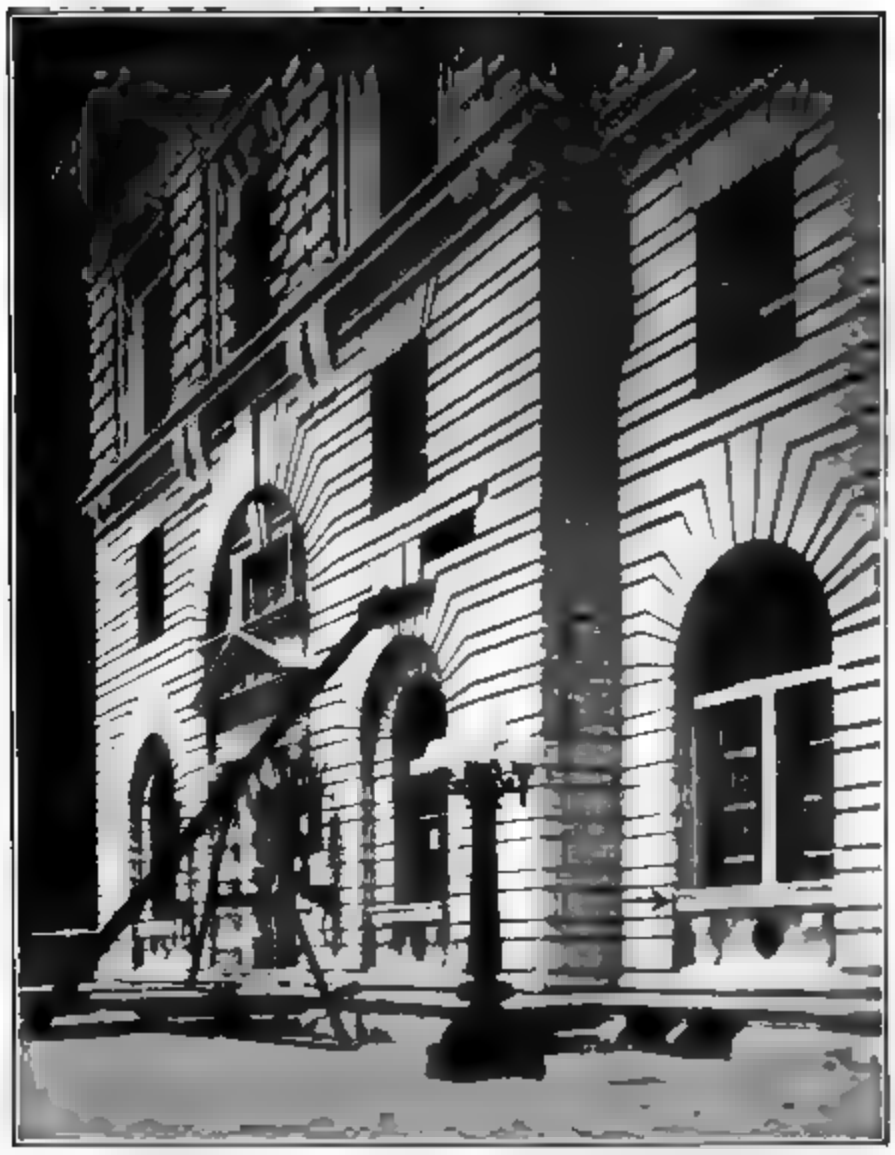
B EFFECT OF SETTLING OF GROUND SUBJECTED TO EARTHQUAKE VIBRATIONS STEEL-FRAME BUILDING UNDER CONSTRUCTION

The concrete basement walls were not reenforced. Post-office in the background. Photograph by Richard L. Humphrey

A CRACKS IN MASONRY PAVILION OF POST-OFFICE, SAN FRANCISCO.

The window reveal and sill were jostled together by the earthquake at the point indicated by the arrow. Photograph by John Stephen Sewell.

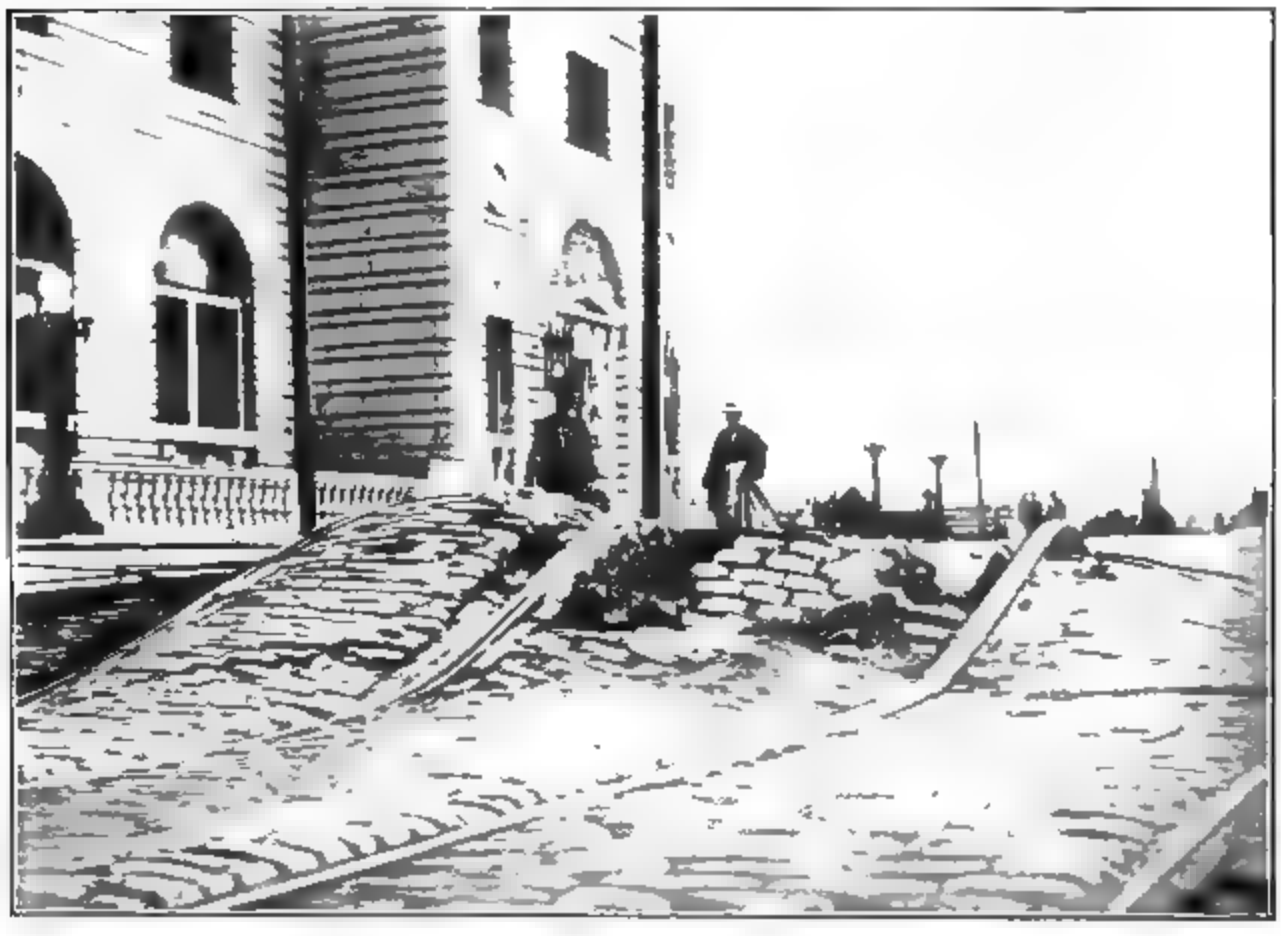
B EFFECT OF SLIP, MISSION STREET, SAN FRANCISCO.

Corner of post-office building at the left. Photograph submitted by Richard L. Humphrey.
